MARINE SAFETY ALERT

Alert 03-14

FAILURE OF HAND PORTABLE FIRE EXTINGUISHER

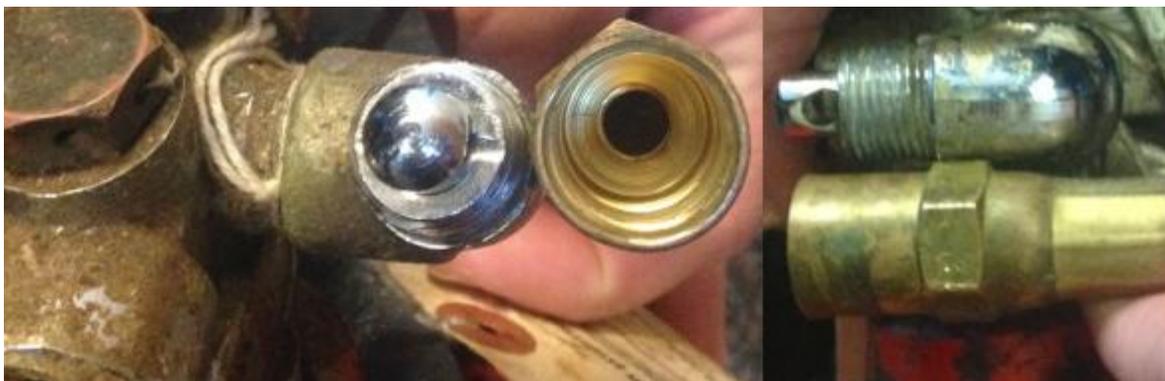
The investigators had the extinguisher examined at a fire-fighting equipment service center. They determined that the hose and discharge horn had been replaced at an earlier time. The end of the hose screws on to a diffuser on the side of the discharge valve/handle assembly of the extinguisher. The diffuser is a ported protrusion on the male end of a ninety degree fitting. On the side of the protrusion are orifices through which the CO₂ flows. The examination revealed that the spherical end of the protrusion, which contains no orifices, bottomed out against the orifice in the connection fitting that leads to the hose and horn assembly. The flow of CO₂ was thus completely blocked.

It was further noted that the male threads of the diffuser were tapered US national pipe threads, while the female threads of the hose connection were straight. This difference likely allowed the hose connection to be tightened further than intended on the diffuser threads, permitting the spherical end of the diffuser to bottom out against the orifice in the tube. This may have also resulted in the reported leakage from the neck of the extinguisher due to back pressure.

Newer types of diffusers exist in which the orifice follows the length of the protrusion and the end is not spherical. However, the issues regarding the tightening of the two components and the importance of ensuring proper lengths and compatibility of the threaded and machined surfaces remain. Binding or bottoming out should not occur except at the threaded surfaces. Replacement parts should be as specified by the original manufacturer of the extinguisher.

The Coast Guard recommends that fire equipment service companies be aware of the potential problems described above, and ensure that all replacement components for servicing hand portable fire extinguishers are as specified by the original extinguisher manufacturer. Service companies that market replacement parts should also note the importance of these concerns and advise their customers accordingly. If the appropriate replacement parts are not available, the extinguisher should be replaced.
